FINAL REPORT
RICHARDSON FLATS TAILINGS
SUMMIT COUNTY, UTAH
TDD #T08-9204-015 and #T08-9210-050
PAN EUT0039SBA and EUT0039SDA

U.S. Environmental Protection Agency
Region VIII
Waste Management Division
Mike Zimmerman, On-Scene Coordinator

Scott Keen
Ecology and Environment, Inc.
Technical Assistance Team

DATE SUBMITTED: February 19, 1993

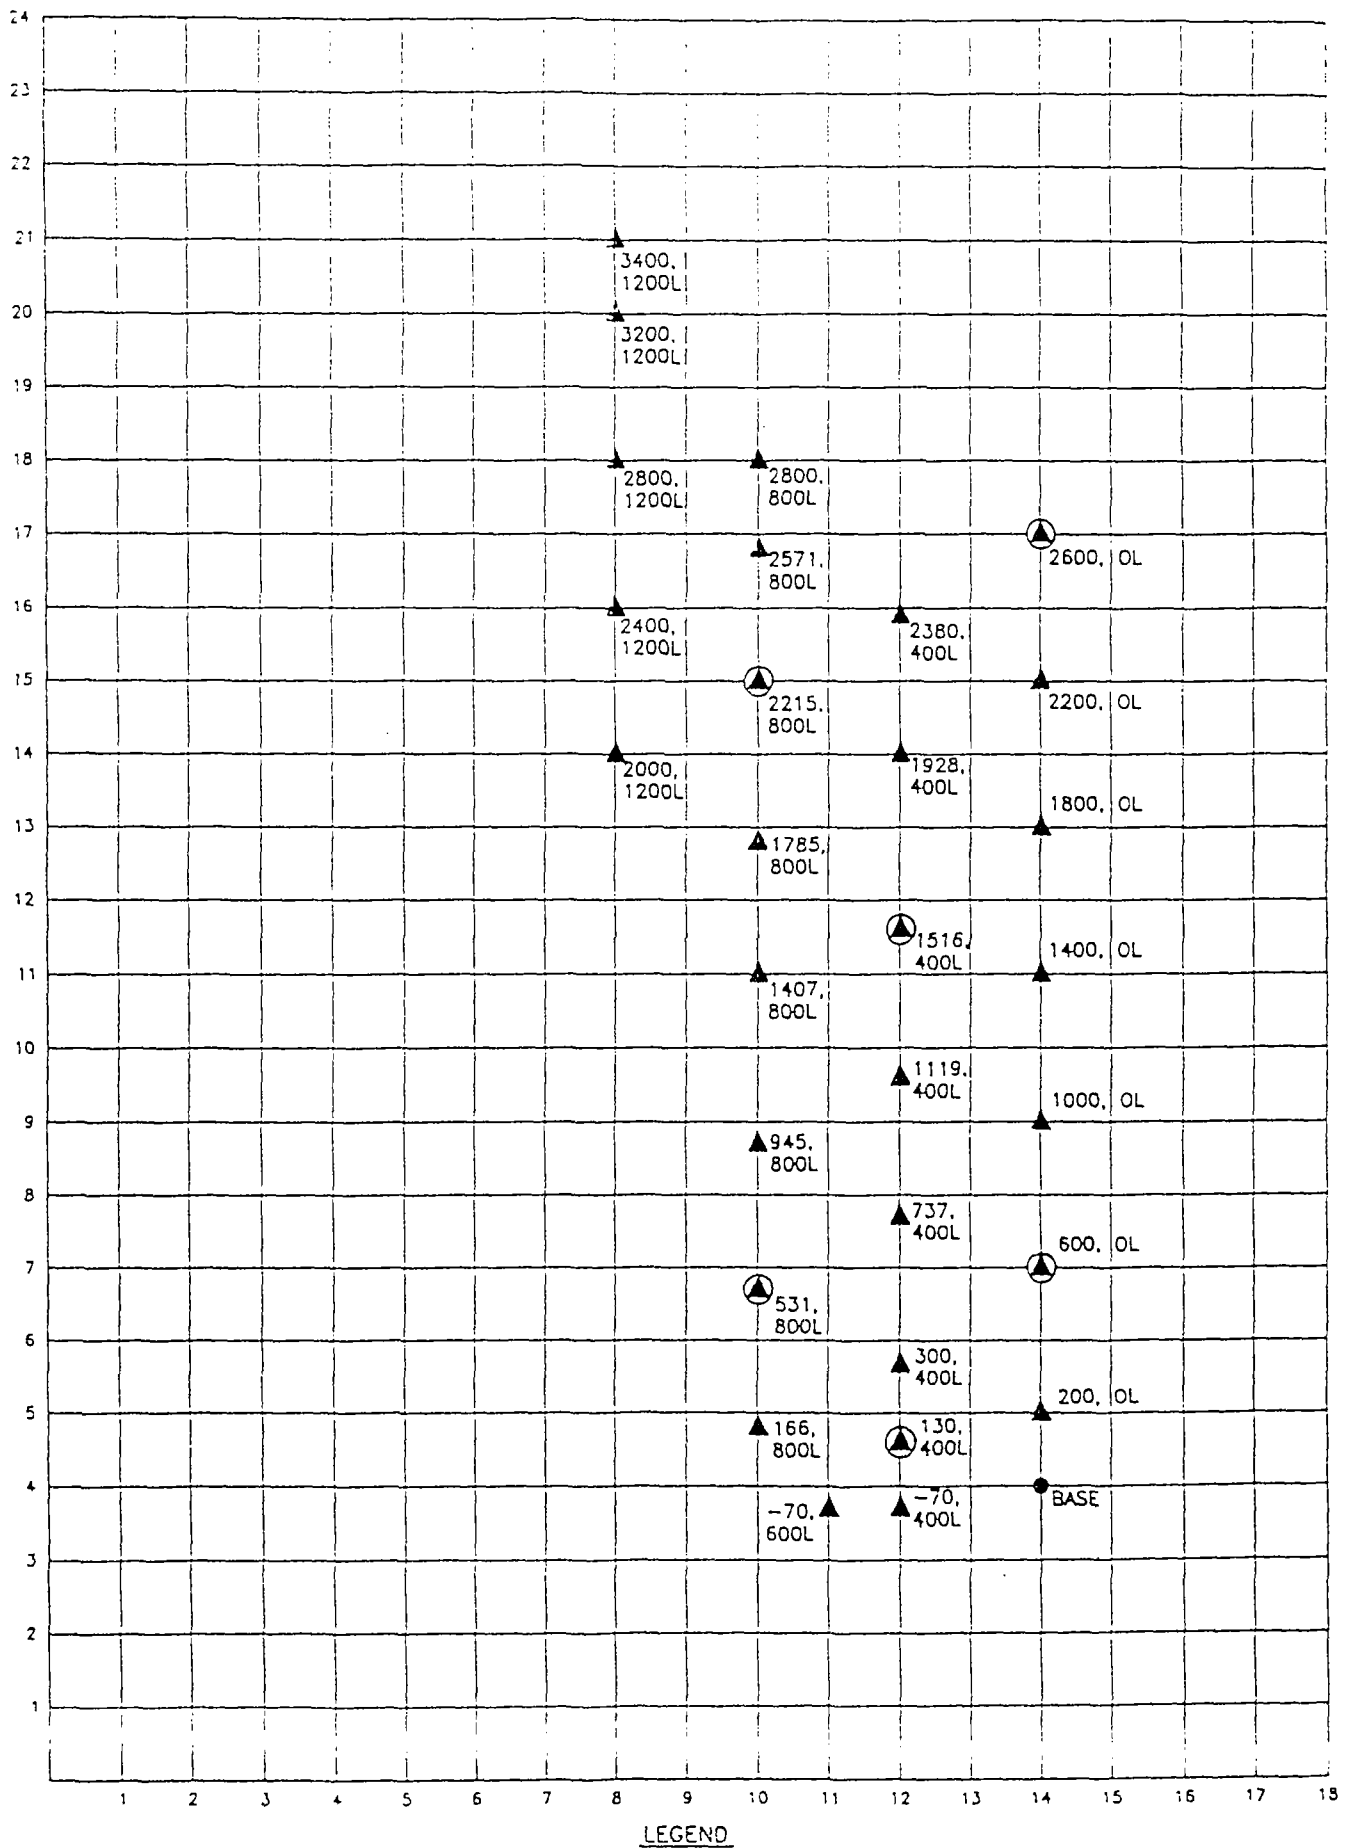
Figure 2
RICHARDSON FLATS

Depth of cover was determined at 29 locations over the tailings area. These locations are depicted on Figure 2. Locations were determined by first establishing a reference line in an approximate direction of northwest to southeast through the tailings area (Figure 1). This reference line includes and is a continuation of a straight portion of the tailings containment structure as shown in Figure 1. Points were marked along this reference line at 200 or 400 foot intervals. At 2800 feet from the base point a second reference line was established in a perpendicular direction to the first reference line. This second reference line extended in an approximate direction from southwest to northeast. For the purpose of sampling or soil cover measurements, all locations within the tailings area were identified relative to these two reference lines. For example, a sample location identified as 1900, 800L would be 1900 feet from the base point (using the first reference line) and 800 feet to the left (northeast) using the second reference line.

The grid pattern shown in Figure 2 represent much of the entire tailings area. Of the 29 points on this grid only 1 point had no cover soil and no salt grass present. Nine of the 29 points (approximately 30 percent) had no cover soil present. At the 20 points where cover soil was present, the cover soil was 6 inches thick or less at 6 points and greater than 6 inches in thickness at 14 points.

Figure 2 shows the location of six soil samples collected on August 6, 1992. Each of these samples, except sample RF-SO-3, was taken from soil that was added by UPCM as cover to the site. Table 2 contains analytical results for these samples and the normal ranges for these elements in soils of the western United States. Sample RF-SO-3 was collected within an area covered by salt grass. As discussed, where salt grass is currently established soil cover has not been added by UPCM. This soil sample is more likely to be representative of tailings material.
